**Subject: ER-Bedford Anodizing Tanks and Vats
Macedonia, Summit County, Ohio
Technical Direction Document No.: S05-000-1308-003
Document Control No.: 2233-2A-BIZR
WESTON START Contract No.: EP-S5-06-04
Work Order No: 20405.012.001.2233.00**

Bedford Anodizing Site Assessment
April 18, 2014

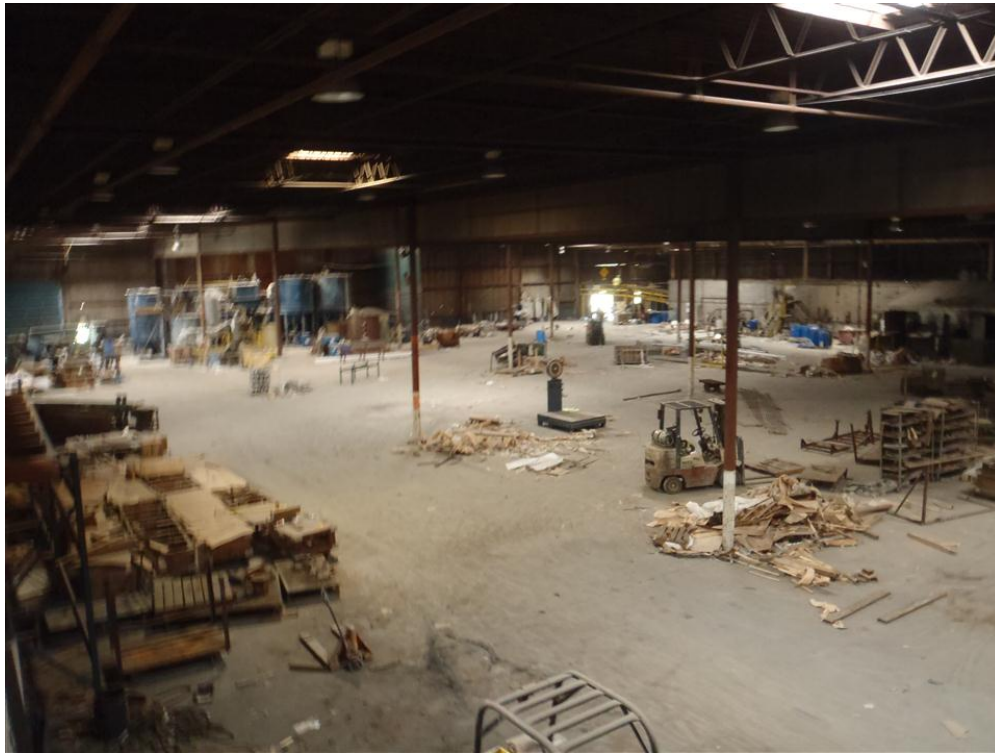
Site: ER-Bedford Anodizing Tanks and Vats
Photograph No.: 1
Direction: Northeast
Subject: General overview of building interior
